TEST REPORT

Report No. : HL40363/2016

The following merchandise was submitted and identified by the applicant as:
Product Description: 5" PIPE HANGER-STEEL GALV.

We have tested the submitted sample as requested and the following results were obtained:
Test Requested: Pulling test

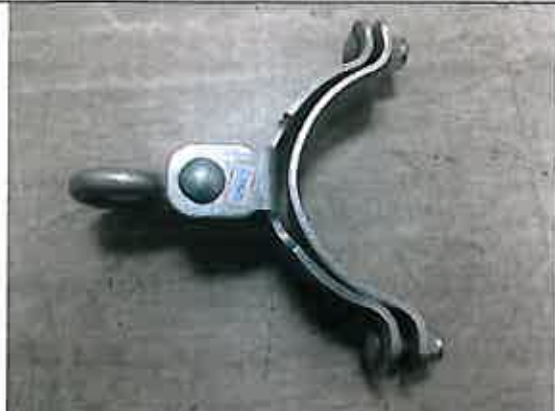
<p>Photo A : Appearance of the sample</p>	<p>Photo B : Test setup</p>
