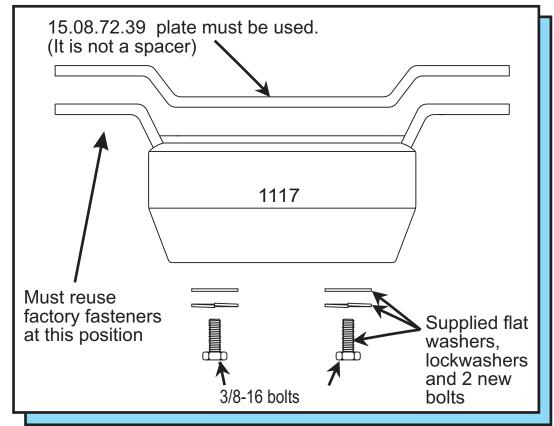
Crossmember center section diagram

Before installing the new mount, be sure to check the transmission crossmember for cracks or damage at the slotted hole areas. On some vehicles, because of the nuts used on the factory studs, it will be necessary to clean out the slots with a file for clearance when using the new bolts. Repair or replace the crossmember if any damage is evident. On high performance (race condition) applications, reinforcing the area around the mounting point of the crossmember is recommended. This type of crossmember had an inherent problem with stress cracks around the bolt holes. Always check the front engine mounts and replace if necessary.
