Test Report

Swing Hanger SH124 Marked Jensen 684613 on Top of Hanger
Country of Origin: China

TEST(S) PERFORMED:	TEST METHOD(S):	RESULT(S):
Salt Spray Test: 5% Salt Solution: 24 hr	ASTM B117	Ref Only

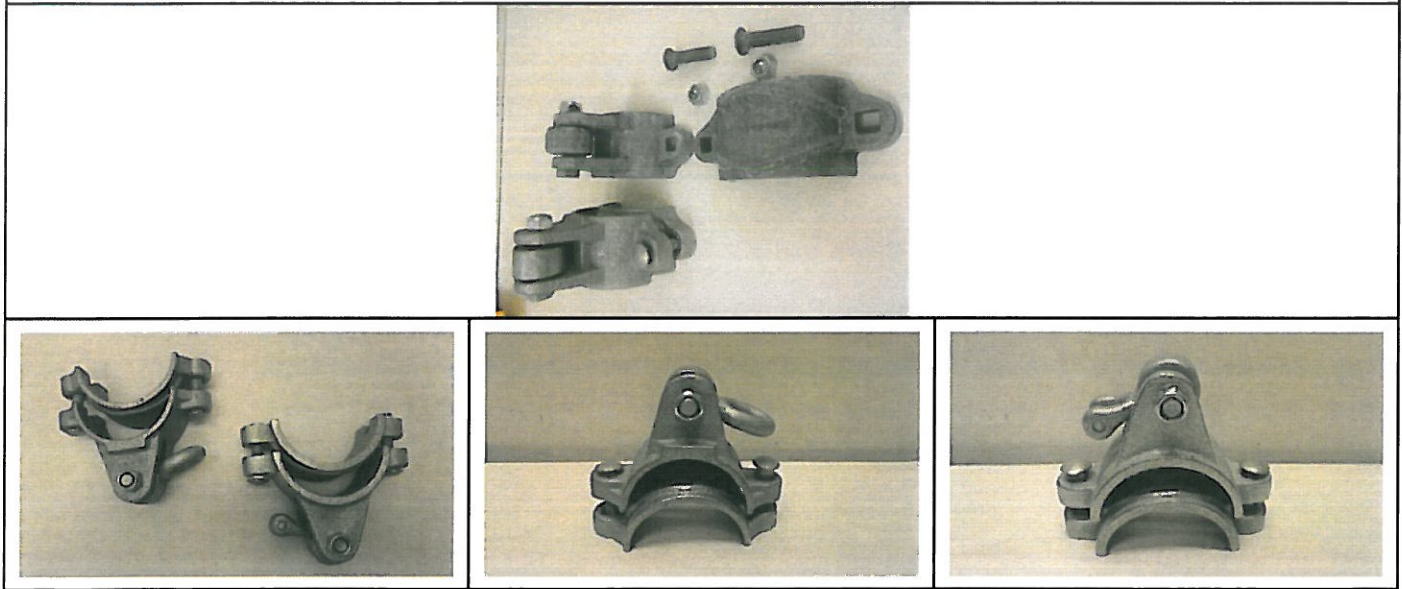
PRODUCT PHOTO(S)

Performance				
Test Property	Test Method/Citation	Product Requirement	Test Results	Rating
Salt Spray Test: 5% Salt Solution: 24 hr	ASTM B117 2011	There shall be no major discoloration or corrosion after 24 hours of exposure to a 5% salt solution.	Sample experienced moderate corrosion. See photo (sample tested is on the top).	Ref Only
