## TEST REPORT

Report No. : HL50596/2015

**The following merchandise was submitted and identified by the applicant as:**Product Description: 2-3/8" DUCTILE W/SHACKLE GALV.Style/Item No.: SH114Country of Origin: TAIWAN**We have tested the submitted sample as requested and the following results were obtained:**Test Requested: Pulling TestTest Method:

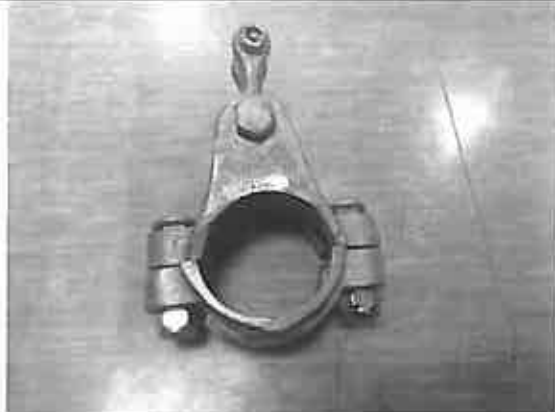
| <p>Photo A : Appearance of the sample</p> | <p>Photo B : Test setup</p> |

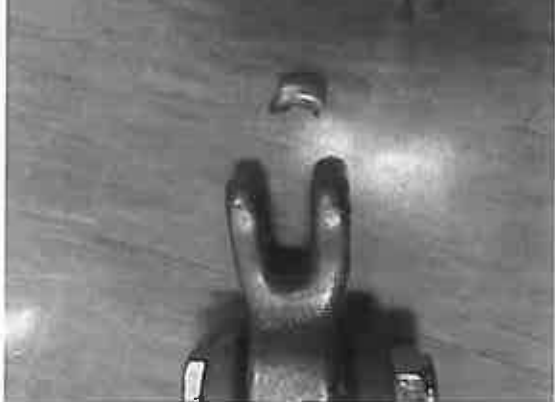
| <p>Photo C : After testing</p> | <p>---</p> |

| Sample | Max. pulling force (kgf) | Result |
|---|---|---|
| 2-3/8" DUCTILE<br>W/SHACKLE GALV. | 8720 <del>3964</del> | The sample was broken after testing.<br>(As shown in photo C) |
