TEST REPORT

Report No. : HL30181/2016

Product Description: NYLON BUSH HANGER 2" RESI

Test Requested: Pulling test

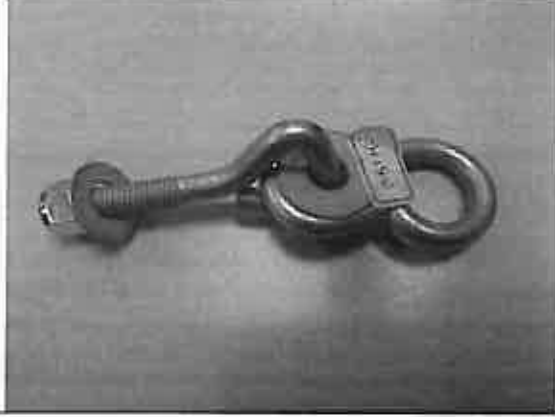
<p>Photo A : Appearance of the sample</p>	<p>Photo B : Test setup</p>
