TEST REPORT

Report No. : HL70279/2012

Product Description: 4-1/2" PIPE HANGER STEEL GALV.

Test Requested: Pulling test

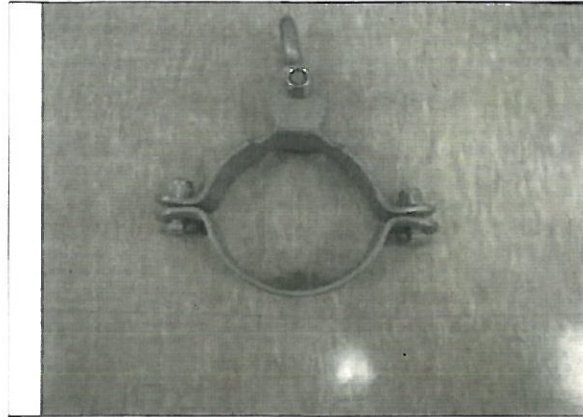
Photo A : Appearance of the sample

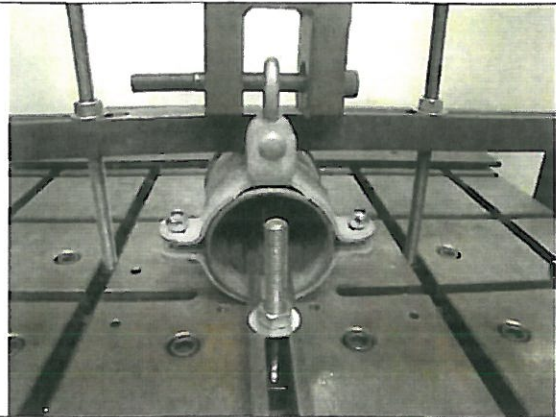
Photo B : Test setup

- Test Method:
1. Secure the sample on the testing machine. (See photo B)
 2. Apply an increasing force to the sample until it is damaged.
 3. Record any findings and Max. pulling force.
 4. Testing Machine: INSTRON 5581, Rate: 5 mm/min.

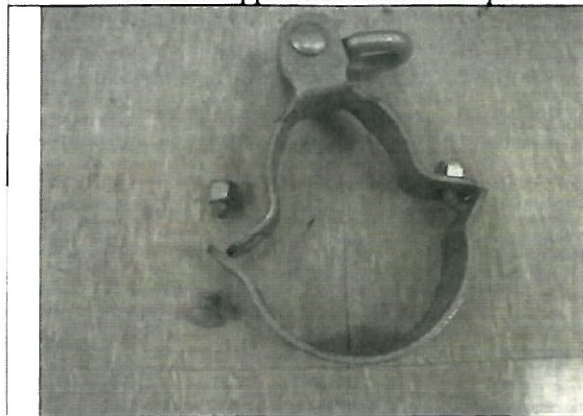
Photo C : After testing

Sample	Max. pulling force	Failure mode
#1	3933.5 kgf	The sample was broken after testing.(See Photo C)
#2	3078.8 kgf	
#3	3768.2 kgf
